Building Inspection Report

Rockcliffe Mansion

1000 Bird,
Hannibal, MO

Inspection Date:
09/18/09

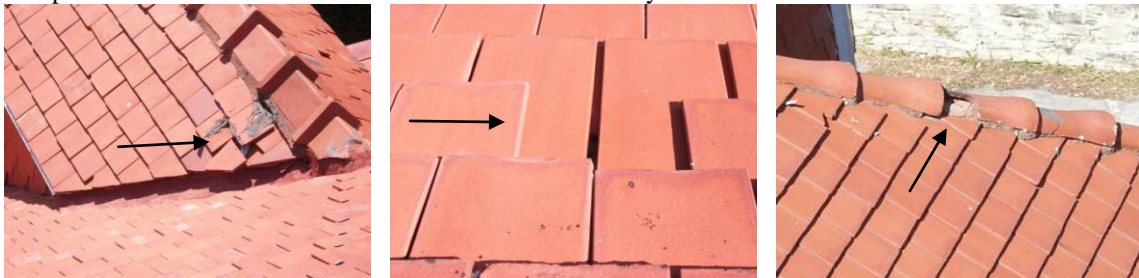
- **Repair:** Minor repairs to the roofing are needed. Damaged or missing roofing material should be repaired. All roof penetrations should be examined and sealed as necessary.

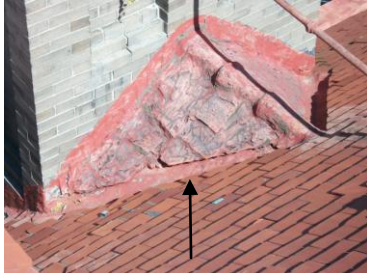
- **Repair:** The flashing is damaged around the boiler chimney and should be repaired to avoid leaks.

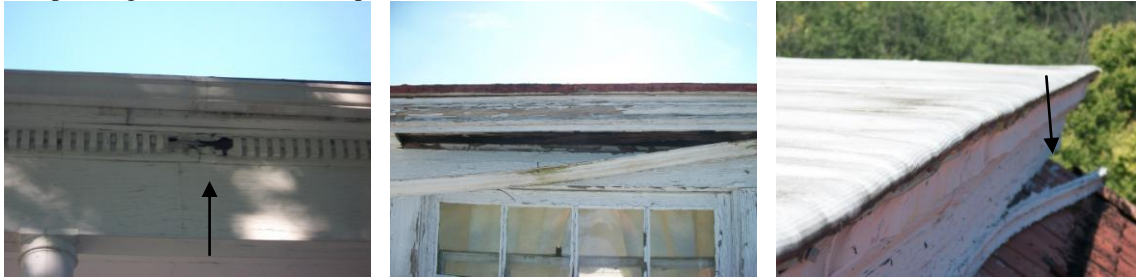
- **Repair:** Localized rot and damage was observed in the fascia (the wooden board to which the gutter is typically fastened) and trim. Improvement is not necessary at present, although this condition should be repaired when exterior painting or maintenance are planned.

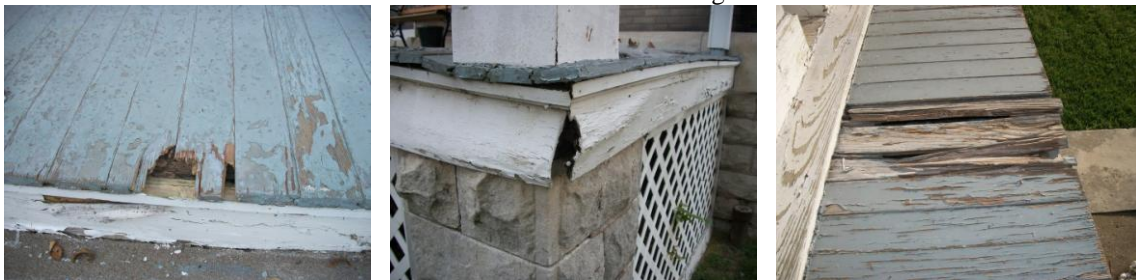
- **Repair:** All porches show evidence of rot. Replacement may eventually be desired. In the interim, localized repairs should be undertaken. There is risk of additional hidden damage.

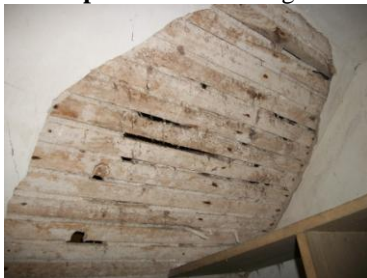
- **Repair:** Water damage was noted in the basement stairwell closet and in the servant stairwell.

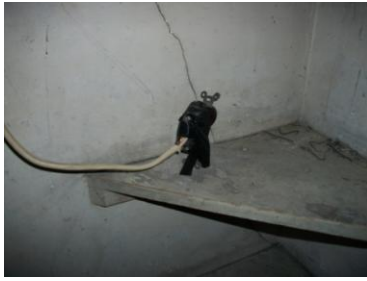
- **Repair:** The sconce light over the book case in the red room is inoperative. If the bulbs are not blown, the circuit should be repaired.
- **Repair:** The sconce light in the rose room bathroom on the right side is inoperative.
- **Repair:** The sconce in Mr. Cruikshank bedroom is inoperative.
- **Repair:** Second floor hall closet light inoperative.
- **Repair:** Outlet hanging in washer room should be secured to wall.

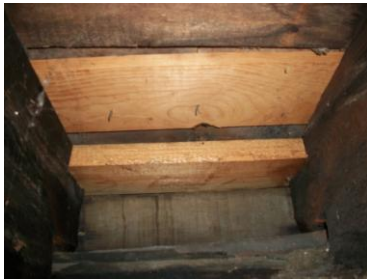
- **Monitor:** The design of the roofing system is such that several vulnerable areas exist most prominently around the dormers. There is a higher potential for leaks. Annual inspections and ongoing maintenance will be critical.
- **Monitor:** Prior repairs to the roofing are evident. This would suggest that problems have been experienced in the past. This area should be monitored.

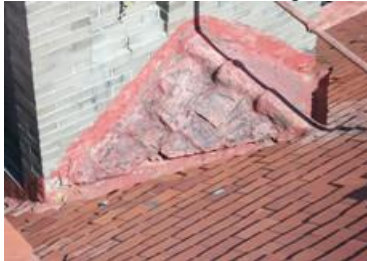
- **Monitor:** The flashing around the boiler chimney is vulnerable and should be carefully monitored for leaks.

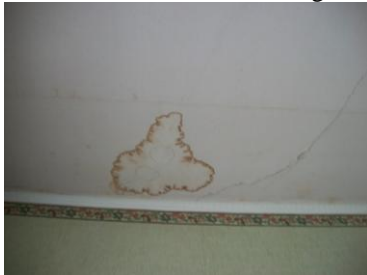
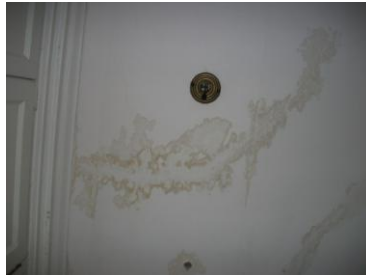
- **Monitor:** Water staining was noted in the ballroom and bathroom between Mr. C room and girl's room.
